RETROFIT TECHNIQUES FOR DISTORTION-INDUCED FATIGUE DAMAGE IN STEEL
BRIDGE GIRDERS

Chapter One:
Use of Composite Block Retrofit for Repairing Distortion –Induced Fatigue Damage at
Cross-Frame Connection Plates

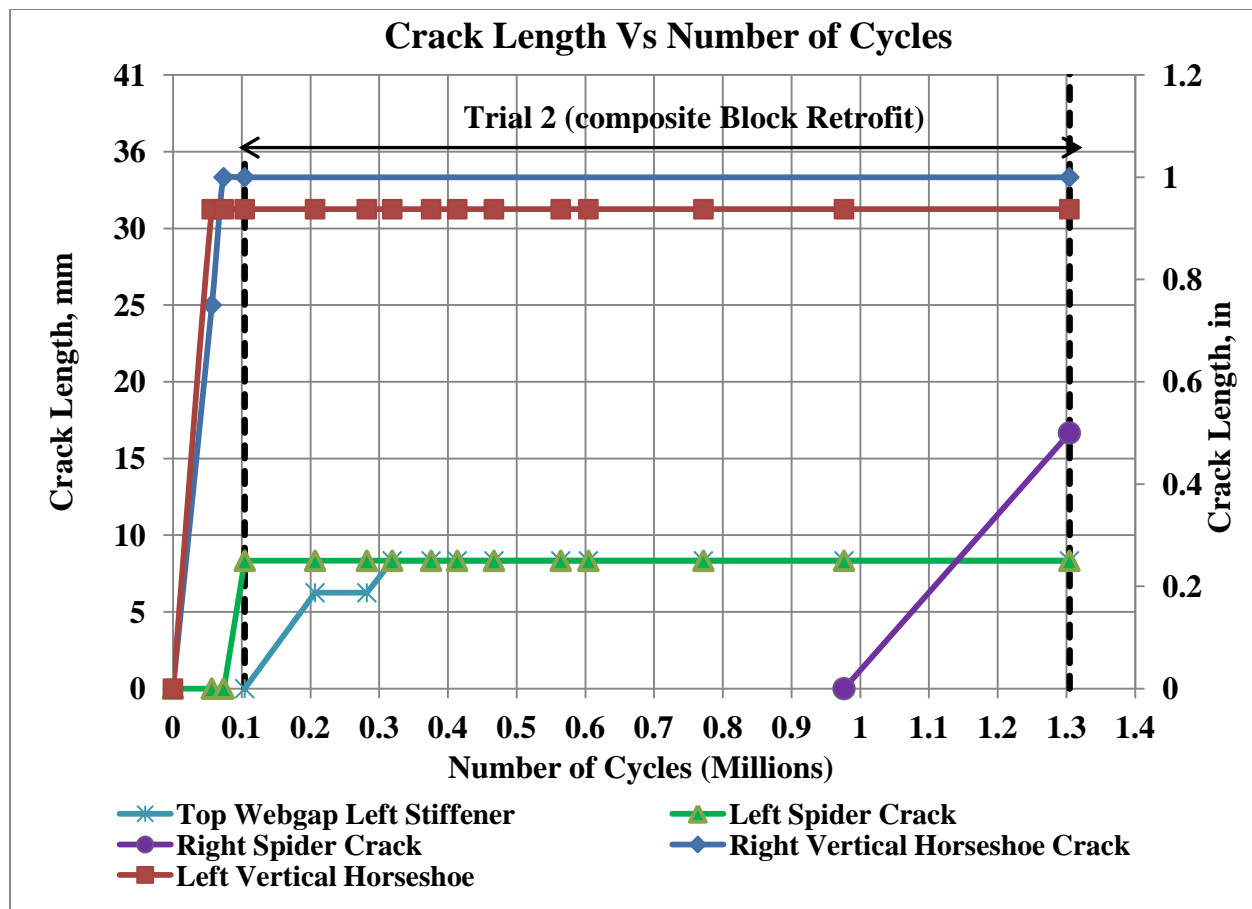
Figure 1-10: Plot of crack length versus cycle count

Results of the physical testing showed that the distortion-induced fatigue life of this girder was significantly improved. The crack propagation rate was slowed significantly when compared to the crack growth rate observed in the test girder without the retrofit. Figure 1-9(a) presents the crack pattern that was recorded during the inspection performed directly before applying composite block retrofit (after Trial 1 and before Trial 2), and Figure 1-9(b) presents the crack pattern recorded after Trial 2 was completed with the retrofit. It can be seen that the only crack that initiated after application of the retrofit was a small spider crack on the right side of the transverse stiffener (Fig.1-10).

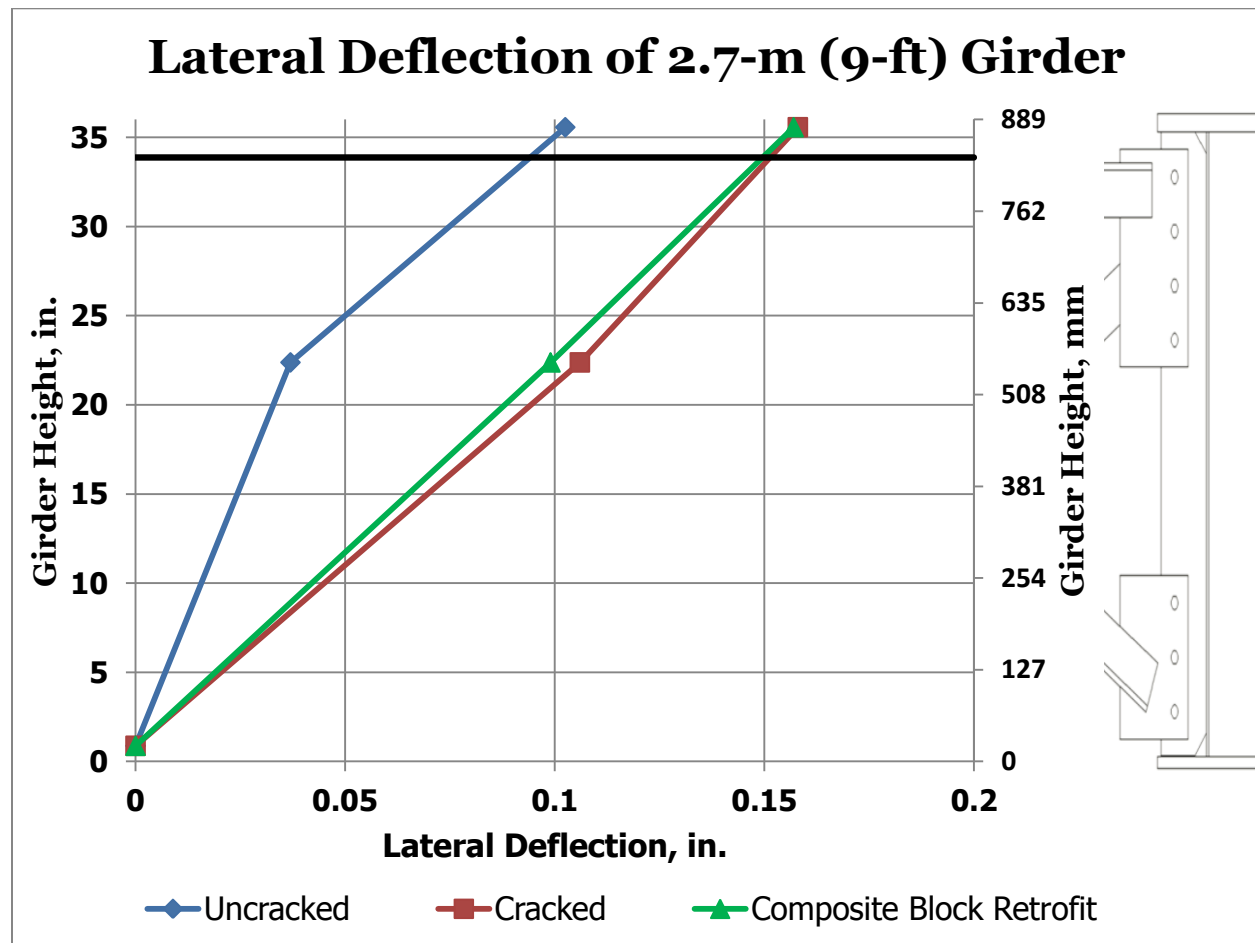
Figure 1-11: Lateral deflection of the specimen before and after the composite block retrofit was applied

Measurement of displacement data showed that inclusion of the composite block retrofit slightly decreased the measured out-of-plane deflections of the girder shown in Figure 1-11.

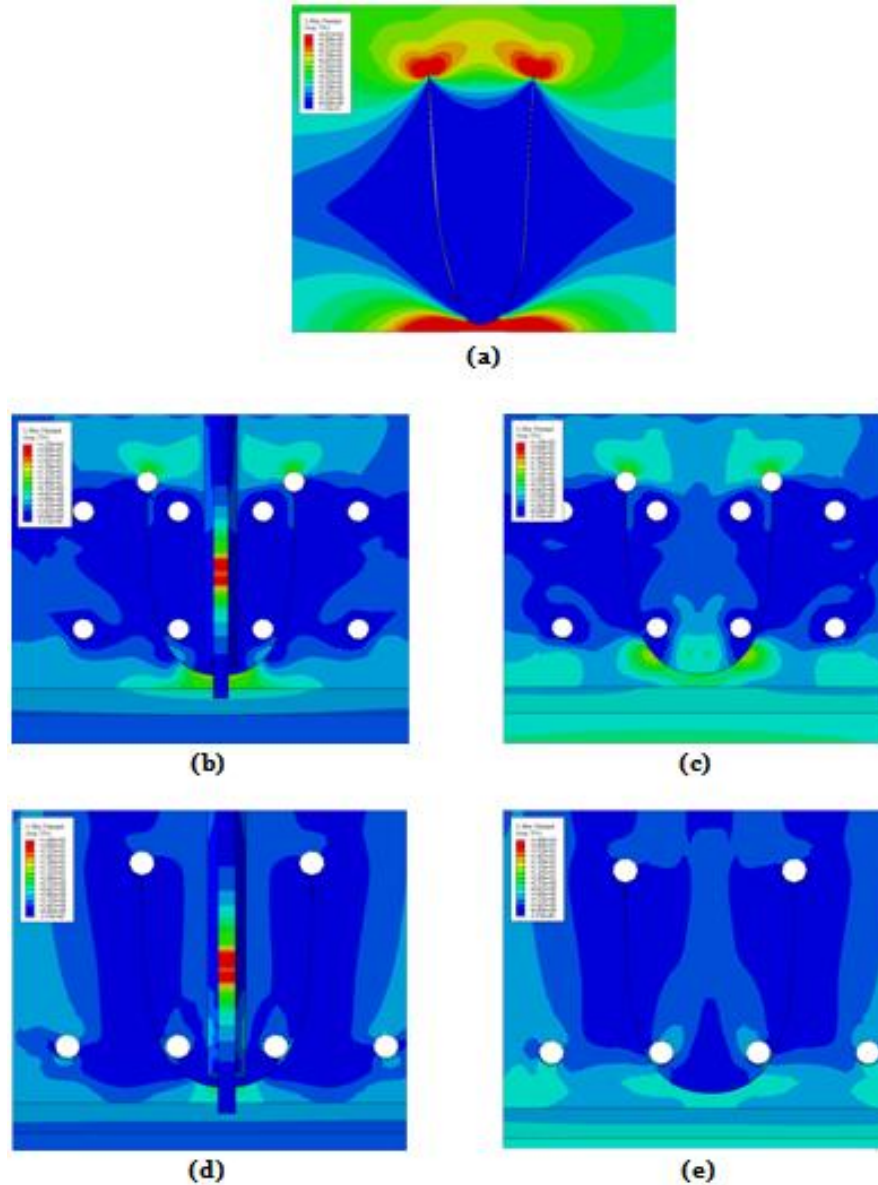
Figure 2-13: Maximum principal stress comparison (a) non-retrofitted (b) retrofitted with full depth splice plate – interior (c) retrofitted with full depth splice – fascia (d) retrofitted with CFRP system – interior (e) retrofitted with CFRP system – fascia (Gangel 2011)

The finite element analyses performed (Gangel 2012) allowed for a comparison between the two retrofit techniques, and it was found that the CFRP-steel plate retrofit measure resulted in the greatest reductions in stress demand. In the non-retrofitted state, high stress (red regions in Fig. 2-13a represent stress values greater than 345-Mpa (50-ksi)) concentrated at three locations: below the horseshoe-shaped crack and at the tips of the crack (Fig.2-13(a)).

The model characterizing the steel girder retrofitted with full depth splice plates on both the interior and exterior faces of the girder's web showed that the high stress concentrations were reduced about 40% (from red to green (about 207-Mpa (30-ksi)) (Fig.2-13(b) and Fig.2-13(c)).

Finally, the model characterizing the steel girder retrofitted with the CFRP and the steel angles-with-plate technique indicated that there was 20% more stress reduction compared to the retrofit without the CFRP layer (Fig.2-13(d) and Fig.2-13(e)).

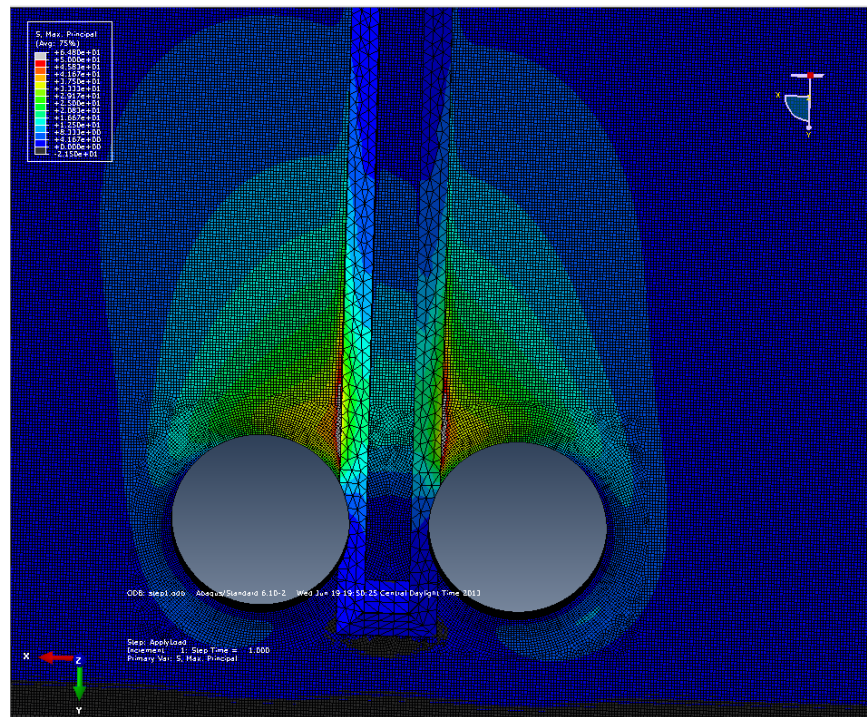
Figure 3-8 Finite Element Model for the girder including one pair crack-arrest holes

The results from the FE model concluded that drilling the first pair of 51-mm (2-in) diameter crack-arrest holes at the tips of the horseshoe-shaped crack eliminated the high stress demand at the tips of the crack. However, the stress concentrated at new locations along the stiffener-to-web weld at a small distance from the edge of the holes. The magnitude of stress was above 345-Mpa (50-ksi), which could have easily resulted in cracking at those locations (Fig.3-8). However, since the highest stress demand did not start at the edge of the holes, the FEA results indicated that cracking would re-initiate a short distance away from the first pair of

crack-arrest holes, again along the connection plate-to-web weld. These findings were in agreement with results from the experimental testing. In the physical testing, it was found that new cracks did not initiate from the first pair of crack-arrest holes until the cycle count reached about 420,000. Then, new cracking initiated located along the connection plate-to-web weld at a distance approximately 13-mm ($1/2$ -in) away from the edge of the holes (Fig.3-11). There was no sign of cracks re-initiating from the edge of the holes.

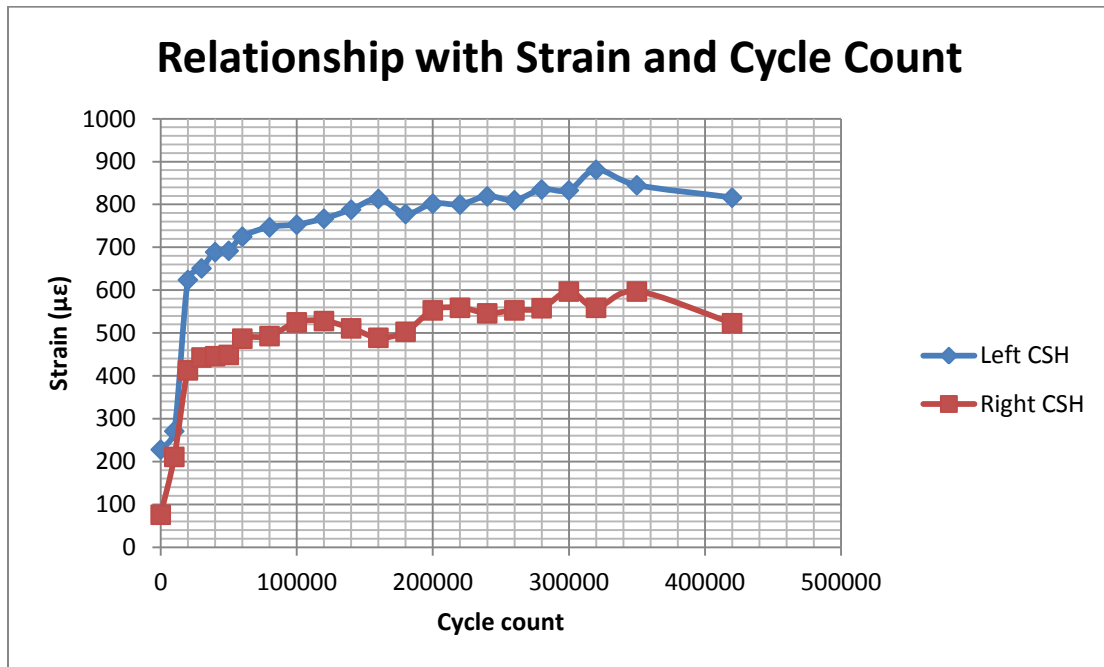
Figure 3-12 Strain data from Left CSH and Right CSH gages both measured at 10-mm ($\frac{3}{8}$ -in) from the edge of the hole (Segment 2)

Strain gages were installed around the holes at 90 degree apart to measure the deformation around the holes. The data from two strain gages were presented in this paper. The gages were named as Left CSH and Right CSH, both located on the top of the holes next to the connection plate-web weld (Fig.3-9 and Fig.3-10). Left CSH was the gage on the left side of the connection plate, and Right CSH was on the right side. Strain data collected from these two strain gages indicated that the magnitude of strain was closed to the strain at yield (Fig.3-12). Also, the strain on the left crack-arrest hole was higher than the strain value obtained on the right crack-arrest hole, which was corroborated by the fact that a crack was first seen on the left side of the connection plate before it was found to have initiated on the right side of the connection plate (Fig.3-11).

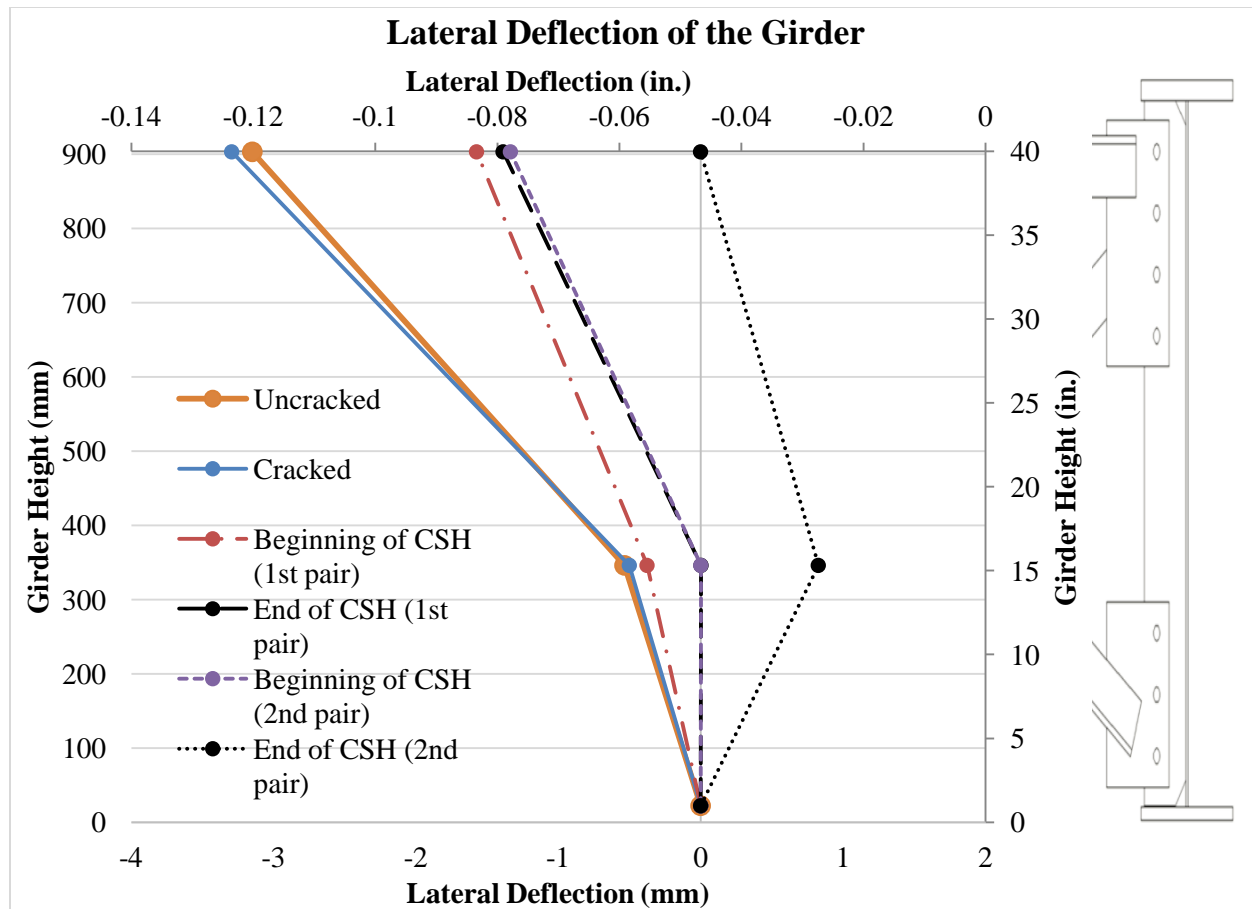
Figure 3-13 Lateral deflection along the height of the girder

The lateral deflection along the height of the girder clearly indicated that the deflection of the girder was increased significantly resulting from the web becoming more flexible due to the presence of the holes (Fig.3-13).

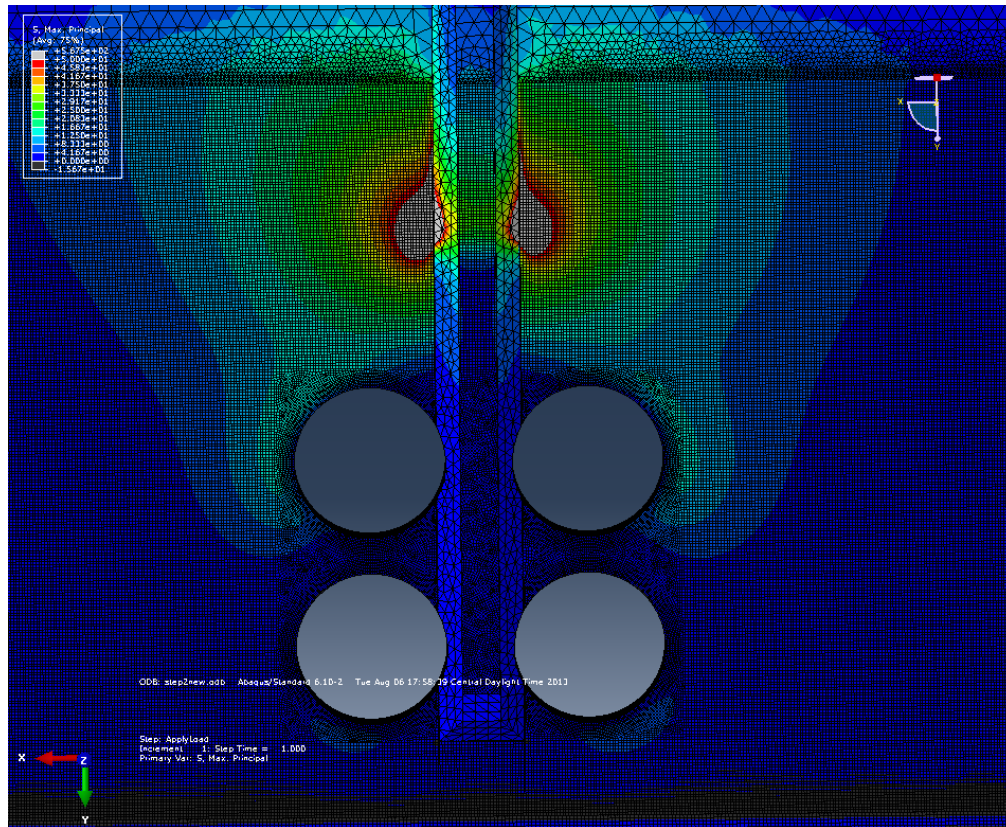
Figure 3-14 Finite element model showing two pairs of crack-arrest holes (cracking modeled explicitly)

The FE model results for the model including the second pair of crack-arrest holes showed that new locations of high stress demand were induced along the connection plate-to-web weld at a distance approximately 38-mm ($1\frac{1}{2}$ -in) from the edge of the holes as shown in Fig.3-14. These results were comparable to the results from the physical testing, which showed that new cracks first initiated at a distance approximately 19-mm ($\frac{3}{4}$ -in) away from the edge of the holes at 980,000 cycles, and then propagated towards the edge of the holes. The lateral deflection along the height of the girder was once again increase greatly as shown in Fig.3-13, and the web became more and more flexible.

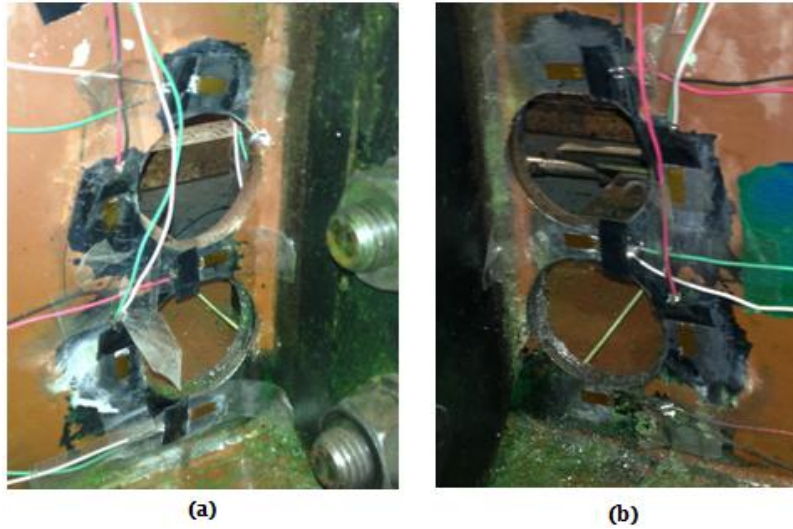
Figure 3-15 Strain gage placement around two pairs of crack-arrest holes in the physical testing. (a) Left side of the connection plate (b) Right side of the connection plate

There were two strain gages installed on the top of the second pair crack-arrest holes at a distance of 10-mm ($\frac{3}{8}$ -in) from the edge of the holes (Fig.3-15). Both gages were denoted as Left CSH and Right CSH. The Left CSH was the strain gage on left side of the connection plate at a distance of 25.4-mm (1-in) from the connection plate-to-web weld (Fig. 3-15(a)), and Right CSH was the strain gage on right side of the connection plate A (Fig. 3-15(b)). The data indicated that the highest strains were located on the right side of the connection plate (Fig.3-16).

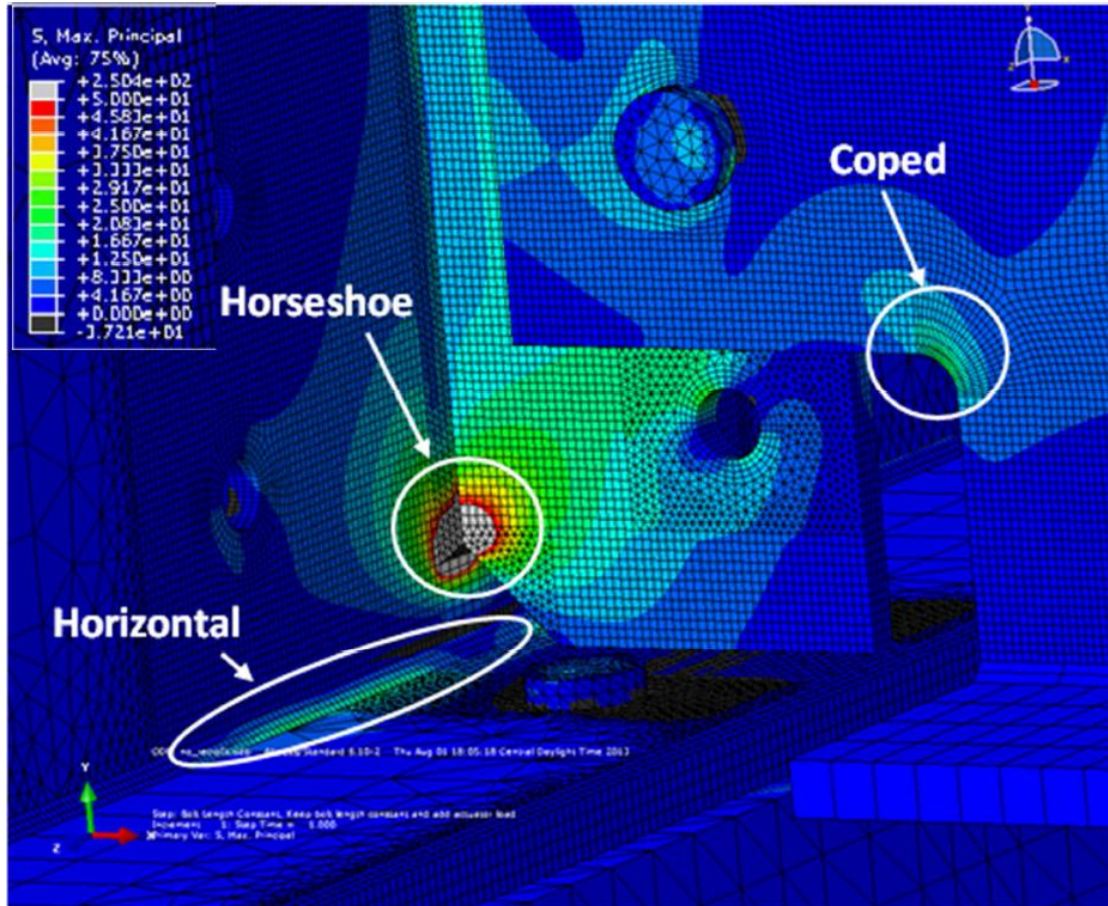
Figure 4-12 Distribution of maximum principal stresses in Type I connection (un-cracked)

The Type I connection detail involved a bolted connection made through the stringer's web and the connection plate welded to the web of the floorbeam. Three locations exhibited high stresses: the connection plate-to-web weld, the web-to-flange weld in the floorbeam, and the cope of stringer. These three locations have been labeled as *Horseshoe*, *Horizontal*, and *Coped* in Fig. 4-12, which shows the distribution of maximum principal stresses in the uncracked model.

The magnitude of principal stresses from highest to lowest was: Horseshoe, Coped and Horizontal. Three successive approaches were taken to eliminate high stress demand at these three locations, as described in the following.

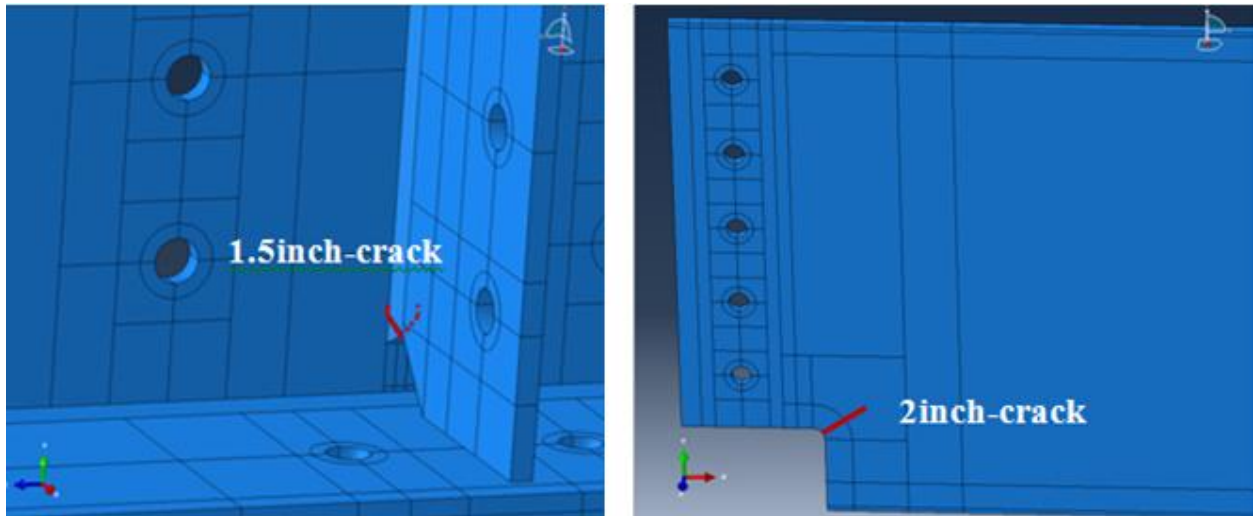
Figure 4-13 Cracks created in the 3D model. a) Horseshoe b) Coped

The first approach examined was to repair the location around the connection plate-to-web weld that had the highest maximum principal stress (labeled as *horseshoe*). A model was generated that included a crack length of 38-mm ($1\frac{1}{2}$ -in) around the stiffener-to-web weld (Fig.4-13a). The crack was modeled explicitly. Then, a retrofit was applied using steel angles and a back plate (Fig.4-14a). This retrofit significantly reduced the high stress demand at the connection plate-to-web weld toe, but stress demands increased at the cope of the stringer.

The second approach examined was to repair the coped location that had exhibited the second highest maximum principal stress demands. An additional 51-mm (2.0-in) long crack was modeled as radiating outwards from the cope at a 45 degree angle (Fig.4-13b). The model

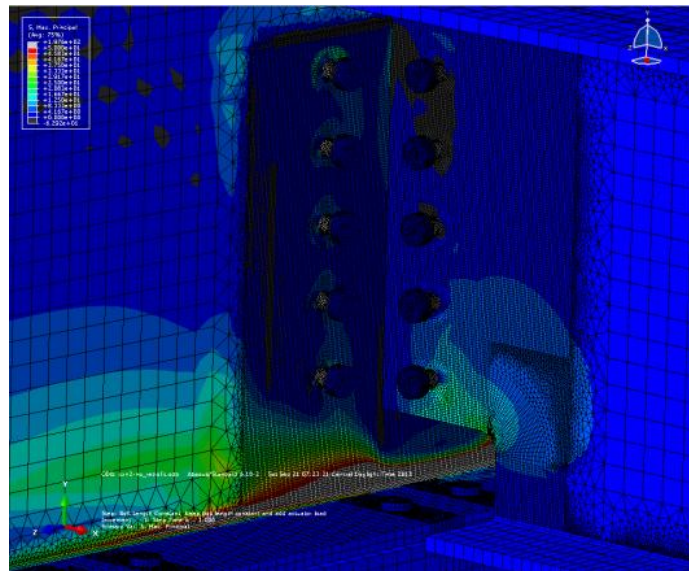
Figure 4-18 CXN#2 stress field on the interior floorbeam (No Retrofit)

The second detail studied in this investigation, Type II Connection, was the stringer-to-floorbeam connection type made by using double angles bolted to the web of the doubly-coped stringer and the web of the floorbeam (Fig.4-17). The FEA showed that there were two critical locations with high stress concentration: the floorbeam web-to-flange weld and the cope of the stringer. The magnitude of stress demand along the web-to-flange weld was found to be higher than the stress at the cope (Fig.4-18).

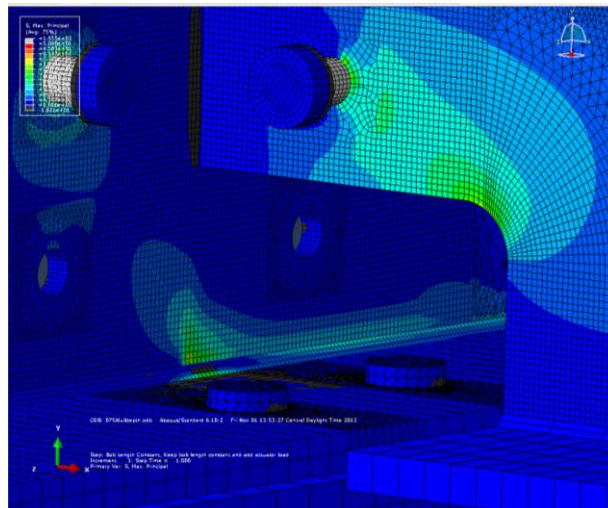
Figure 4-20 CXN#2 stress field on interior floorbeam (Retrofitted)

The first approach taken to reduce the stress demands along the web-to-flange weld was to replace the double angles used in the original Type II connection with longer angles that were the same height as the web. The longer angles could diverge the stress concentration from the web-to-flange weld area to the wider web area of the floorbeam. The FE results showed great reduction of stresses along the web-to-flange weld (Fig.4-19 and Fig.4-20).

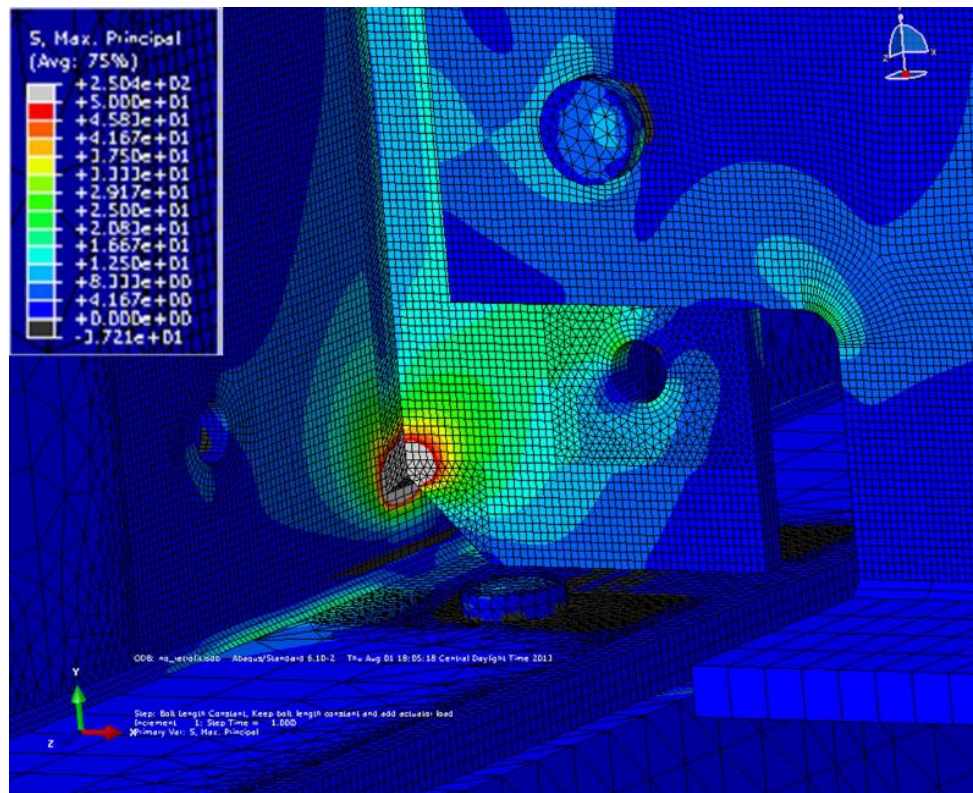
Figure 4-22 High stress demand in un-retrofitted model (un-cracked) (Type 1 Connection)

In the un-retrofitted stage, the FE results showed high stress concentrations located at three different regions, of which the connection plate-to-web weld toe experienced the highest local stress demands (Fig.4-22). This result was also in agreement with the result from physical testing in which it was observed that cracks first initiated at the connection plate-to-web weld toe (Fig. 4-23). Three strain gages at three different locations were chosen to observe the variation in deformation as the number of cycles increased. Those strain gages were labeled as Gage WBS (*Horizontal*), Gage BS (*Horseshoe*), and Gage CStr0.1875 (*Coped*), and the locations were shown in figure 4-7 and figure 4-8. The data recorded indicated to have the highest magnitudes at the connection plate-to-web weld toe with a maximum of $1450\mu\epsilon$. As more and more cycles were applied, the strains at the cope gradually increased whereas the strains at the flange-to-web weld decreased (Fig.4-24).

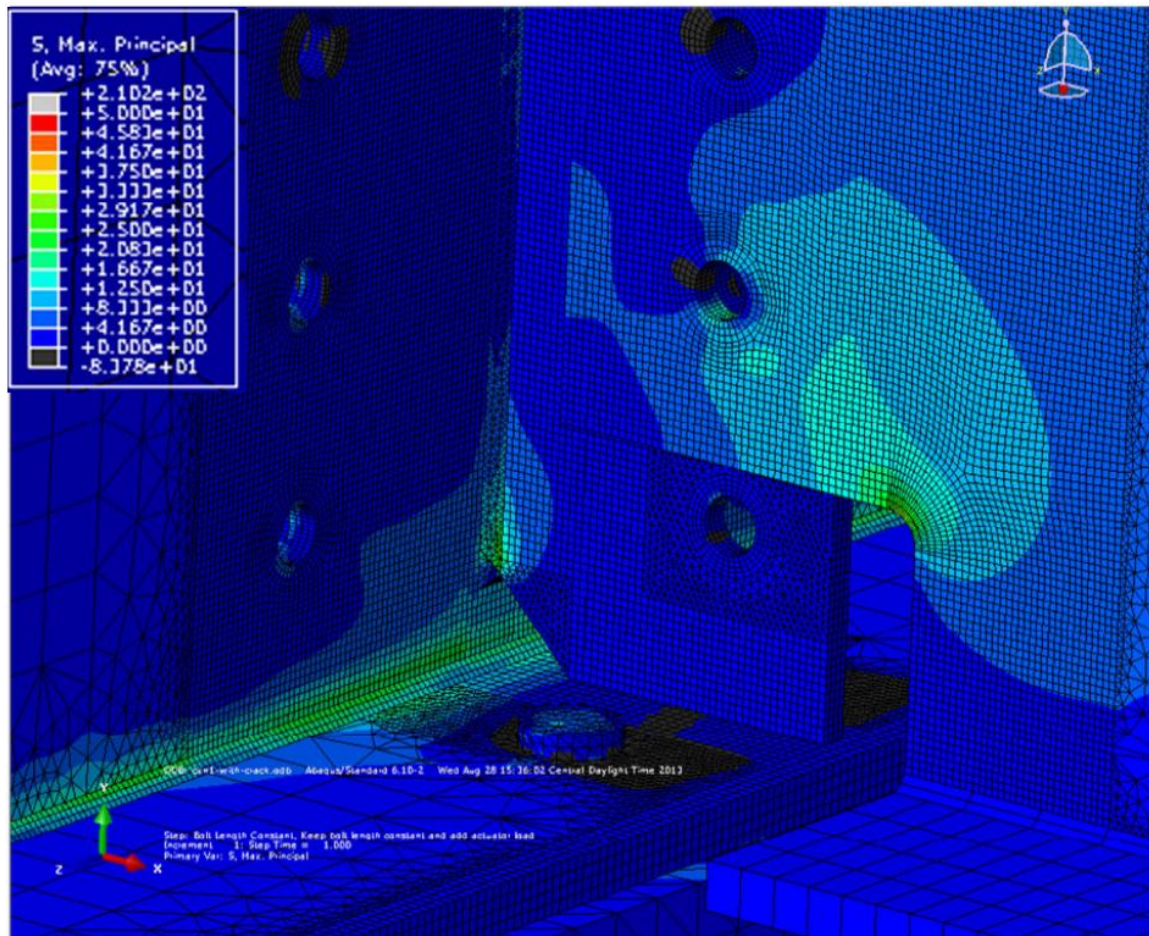
Figure 4-25 Stress field in Type I connection with angles-and-back-plate retrofit

Results from the retrofitted simulation showed that the maximum principal stress demand at the connection plate-to-web weld toe was reduced by 74.3%. However, maximum principal stresses at the cope of the stringer and at the flange-to-web weld were shown to increase after the retrofit by 40.9% and 322.4%, respectively (Fig.4-25 & Table 4-1). Since the maximum principal stress demand at the cope was slightly greater than at the flange-to-web weld, it was surmised that cracking might first initiate at the stringer cope. Thus, the L-shape retrofit was next applied, replacing the angles.

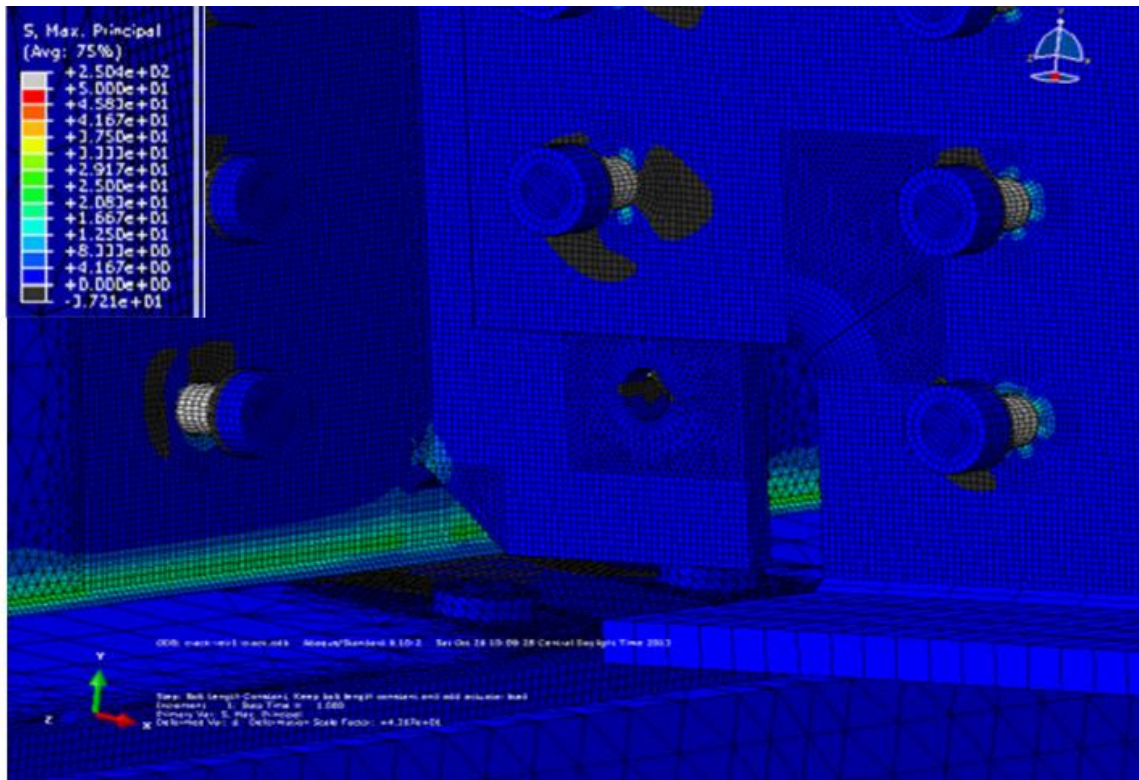
Figure 4-26 Stress field in Type I connection after applying L-shaped retrofit

The model including the L-shape retrofit showed that the controlling maximum principal stress at the cope was reduced by 97.2%. The magnitude of principal stress at the flange-to-web weld was increased from 33.8-MPa (4.9-ksi) to 145.5-MPa (21.1-ksi) (Fig.4-26 & Table 4-1).

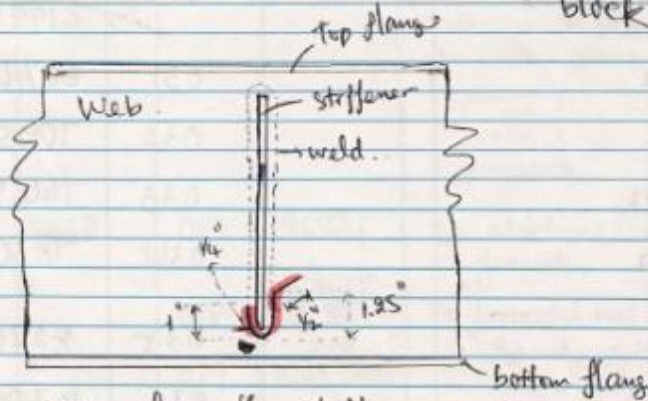
Map of the cracks after removing composite block.

View from the stiffener side.

Stiffener side : left vertical crack = 1"

left spider crack = $\frac{1}{4}$ "

right vertical crack = 1.25"

right spider crack = $\frac{1}{2}$ "

fascia side : $1\frac{5}{16}$ " horizontal web crack

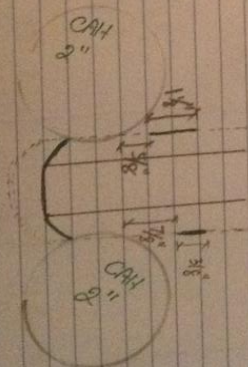
The crack above grew to 1/8"

The crack grew to 1/8" downwards and a new crack on the right stiffener appeared.

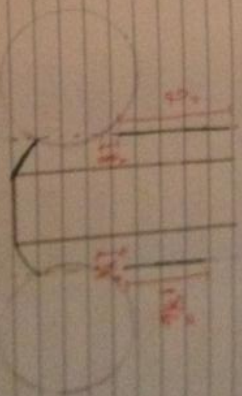
Left pile grew to 3" (1 1/2" gap above the test cell)
right pile grew to 1 1/2" (1/2" gap above the test cell)

Drilling another ~~test~~ crack-stop hole

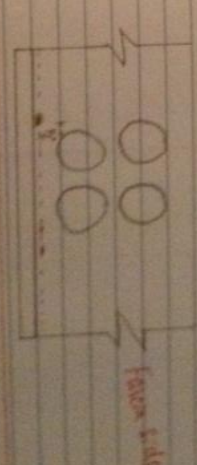
$\frac{1}{16}$ " horizontal cracks on left on joint side about $\frac{1}{2}$ " from CSA

Two horizontal cracks on stiffener side. 0.15" and $\frac{1}{16}$ " long with 0.125" apart.

Stiffener side
